Technical Report OPS 89-11

**ELECTRIC RESISTANCE WELD PIPE FAILURES
ON HAZARDOUS LIQUID AND GAS TRANSMISSION PIPELINES**

AUGUST 1989

**Office of Pipeline Safety
Research and Special Programs Administration
U.S. Department of Transportation**

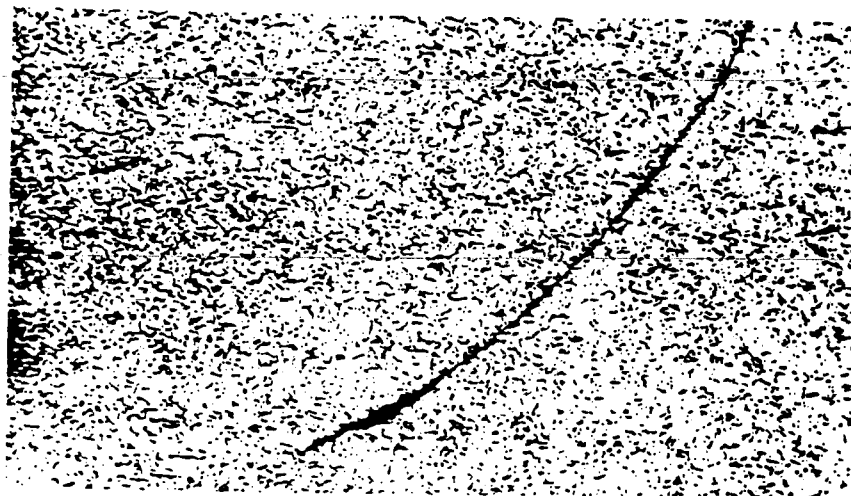
Figure C-4 Nonmetallic Inclusions Aligned With Grain Flow

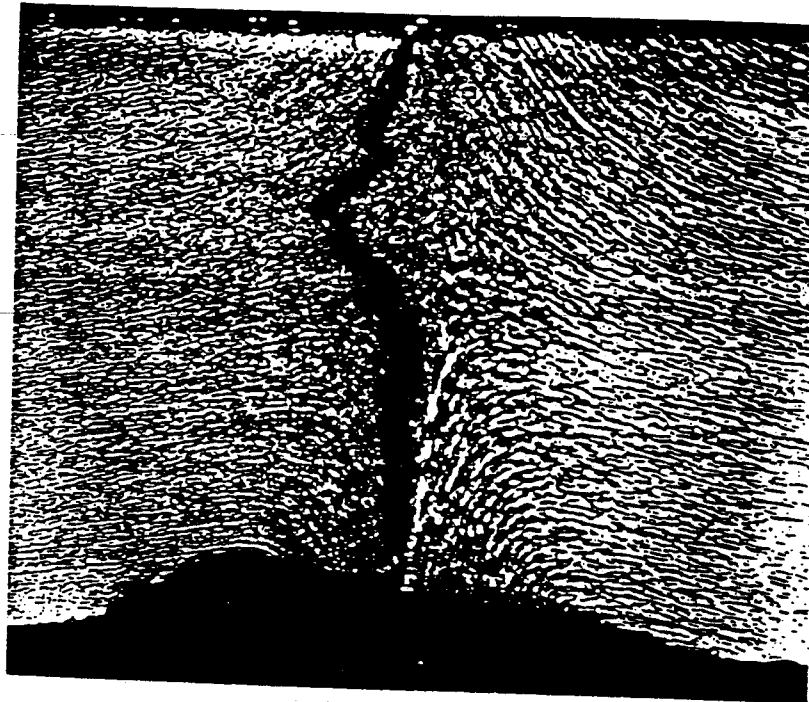
Figure C-6 Excessive Trim on the Inside Diameter

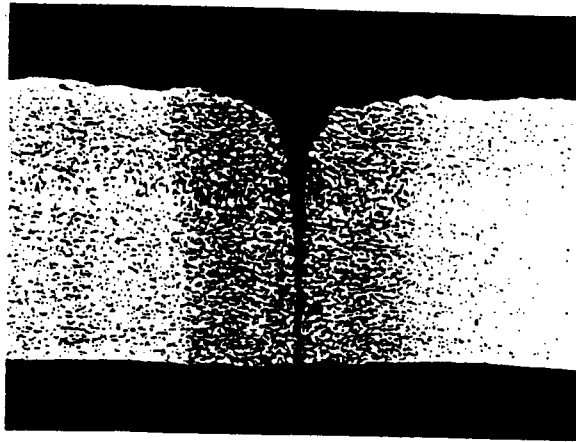
(a) Section From Station 71.5
WPL, Mounds View

Figure C-7 Selective Corrosion
